**Flood Control Project Maintenance
Levee Inspections**
LMA District Cover Sheet
Spring 2017 Levee Inspection Results

Reclamation District No. 2064 River Junction

Spring 2017 Levee Inspection Results

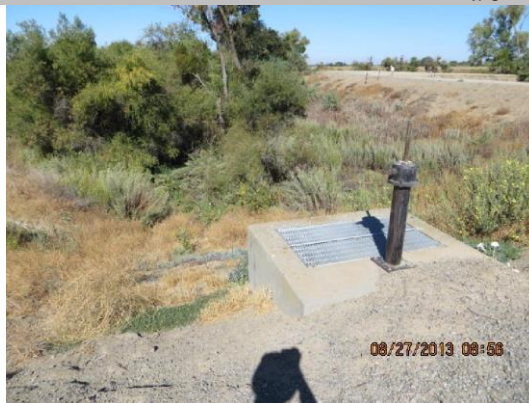
Photo 1 of 3 : UCIP_SP_2017_43603_31258.jpg

LM Start	0.06	Rating **	A/W	Issue No.	28
LM End	0.06	Issue Type +	Ma	Location *	LS
Category	Supplemental			GPS Latitude/Longitude	
				Start	End
Item	DWR UCIP LMA Responsibility			37.709804 °	37.709804 °
				-121.267559 °	-121.267559 °
DWR ID					
Comment Code					
Inspector Comment					
FS_ID:43603 DS_ID:20511 EP_NO: N/A Repair Type: No Action Needed Crossing Status: Found UCIP Comments: Debri removed from flap gate on waterside tow FIELD_STRUCT_DESC: 36-inch square reinforced concrete storm drain box culvert through the levee 21.0 feet below the crown. Concrete "U" shaped headwalls on both ends. Slide gate in 6'X7' concrete riser unit on the waterward slope. Flap gate on the waterward end. Flashboard slots on the landside headwall. Originally included in the 1968 O&M manual. FS Date: 3/2/2015

Slide gate in concrete riser on WS shoulder.

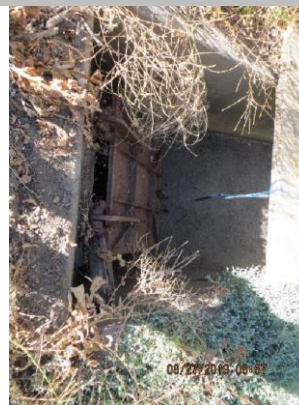
Photo 2 of 3 : UCIP_SP_2017_43603_31257.jpg

Flap gate and U shaped headwall on WS toe. Debris blocking closure of gate.

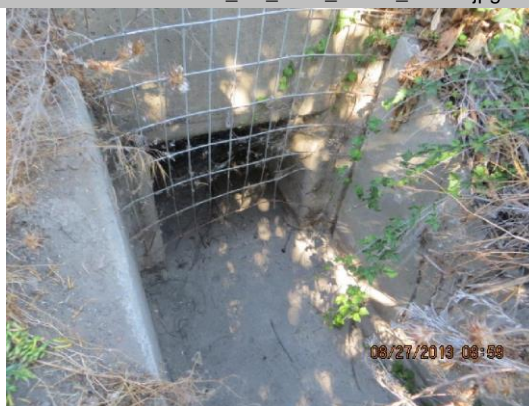
Photo 3 of 3 : UCIP_SP_2017_43603_31256.jpg

LM Start	0.06	Rating **	A/W	Issue No.	28 (cont)	
LM End	0.06	Issue Type +	Ma	Location *	LS	
Category	Supplemental			GPS Latitude/Longitude		
				Start		End
Item	DWR UCIP LMA Responsibility			37.709804 °		37.709804 °
				-121.267559 °		-121.267559 °
DWR ID						
Comment Code						
Inspector Comment						
FS_ID:43603 DS_ID:20511 EP_NO: N/A Repair Type: No Action Needed Crossing Status: Found UCIP Comments: Debris removed from flap gate on waterside tow FIELD_STRUCT_DESC: 36-inch square reinforced concrete storm drain box culvert through the levee 21.0 feet below the crown. Concrete "U" shaped headwalls on both ends. Slide gate in 6'X7' concrete riser unit on the waterward slope. Flap gate on the waterward end. Flashboard slots on the landside headwall. Originally included in the 1968 O&M manual. FS Date: 3/2/2015

Concrete headwall at inlet on LS toe.

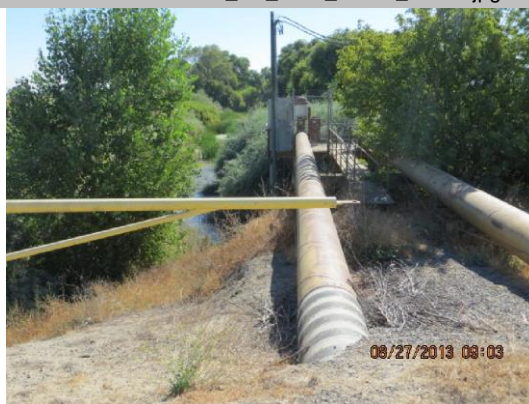
Photo 1 of 3 : UCIP_SP_2017_18718_31286.jpg

LM Start	0.06	Rating **	M	Issue No.	29
LM End	0.06	Issue Type +	En	Location *	LS
Category	Supplemental			GPS Latitude/Longitude	
				Start	End
Item	DWR UCIP Field Study			37.709725 °	37.709725 °
				-121.267534 °	-121.267534 °
DWR ID					
Comment Code					
Inspector Comment					
FS_ID:18718					
DS_ID:20512					
EP_NO: 13907					
Repair Type: Non-Urgent					
Crossing Status: Found					
UCIP Comments: This pipe has less than 1-foot of cover.					
FIELD_STRUCT_DESC: 1 of 3: 24-inch stormdrain discharge pipe					
through the levee 2.0 feet below the crown (Permit No. 13907, 1985).					
Two 100-horsepower and one 75-horsepower pumps on landward toe of					
levee. Siphon breaker on WS shoulder.					
FS Date: 8/27/2013

Steel storm drain pipe with pump on pier in background.

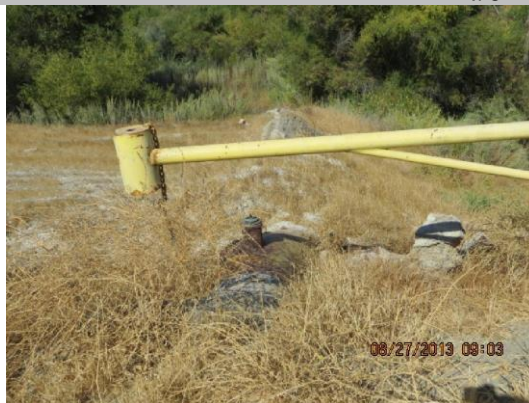
Photo 2 of 3 : UCIP_SP_2017_18718_31285.jpg

LM Start	0.06	Rating **	M	Issue No.	29 (cont)	
LM End	0.06	Issue Type +	En	Location *	LS	
Category	Supplemental			GPS Latitude/Longitude		
				Start	End	
Item	DWR UCIP Field Study			37.709725 °	37.709725 °	
				-121.267534 °	-121.267534 °	
DWR ID						
Comment Code						
Inspector Comment						
FS_ID:18718						
DS_ID:20512						
EP_NO: 13907						
Repair Type: Non-Urgent						
Crossing Status: Found						
UCIP Comments: This pipe has less than 1-foot of cover.						
FIELD_STRUCT_DESC: 1 of 3: 24-inch stormdrain discharge pipe						
through the levee 2.0 feet below the crown (Permit No. 13907, 1985).						
Two 100-horsepower and one 75-horsepower pumps on landward toe of						
levee. Siphon breaker on WS shoulder.						
FS Date: 8/27/2013

Pipe and siphon breaker visible on WS shoulder.

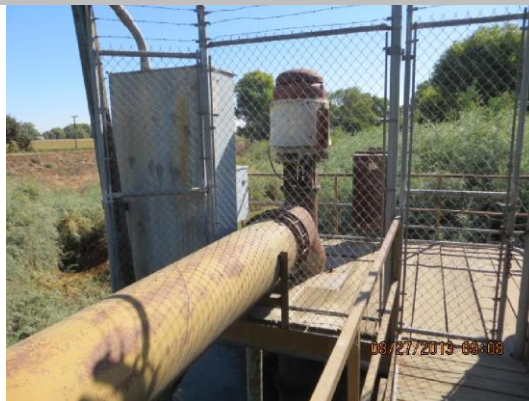
Photo 3 of 3 : UCIP_SP_2017_18718_31284.jpg

Pump on wooden pier on LS toe.

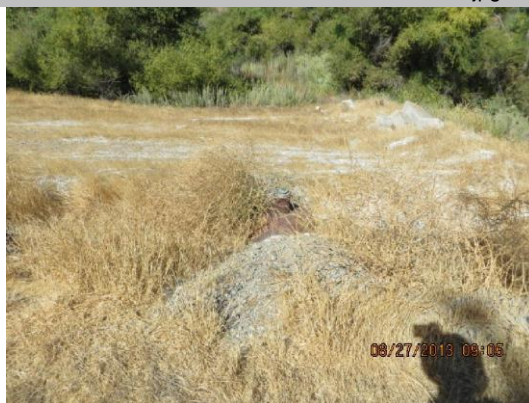
Photo 2 of 3 : UCIP_SP_2017_22729_38457.jpg

LM Start	0.06	Rating **	M	Issue No.	30
LM End	0.06	Issue Type +	En	Location *	LS
Category	Supplemental			GPS Latitude/Longitude	
				Start	End
Item	DWR UCIP Field Study			37.709698 °	37.709698 °
				-121.267536 °	-121.267536 °
DWR ID					
Comment Code					
Inspector Comment					
FS_ID:22729					
DS_ID:20527					
EP_NO: 13907					
Repair Type: Non-Urgent					
Crossing Status: Found					
UCIP Comments: This pipe has less than 1-foot of cover.					
FIELD_STRUCT_DESC: 2 of 3: 24-inch steel stormdrain discharge pipe					
through the levee 2.0 feet below the crown (Permit No. 13907, 1985).					
Two 100-horsepower and one 75-horsepower pumps on pier at					
landward toe of levee. Siphon breaker on WS shoulder.					
FS Date: 8/27/2013

Pipe and siphon breaker on WS shoulder.

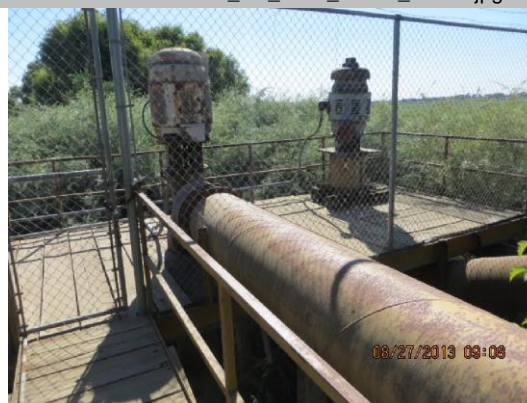
Photo 3 of 3 : UCIP_SP_2017_22729_38456.jpg

LM Start	0.06	Rating **	M	Issue No.	30 (cont)
LM End	0.06	Issue Type +	En	Location *	LS
Category	Supplemental			GPS Latitude/Longitude	
				Start	End
Item	DWR UCIP Field Study			37.709698 °	37.709698 °
				-121.267536 °	-121.267536 °
DWR ID					
Comment Code					
Inspector Comment					
FS_ID:22729					
DS_ID:20527					
EP_NO: 13907					
Repair Type: Non-Urgent					
Crossing Status: Found					
UCIP Comments: This pipe has less than 1-foot of cover.					
FIELD_STRUCT_DESC: 2 of 3: 24-inch steel stormdrain discharge pipe					
through the levee 2.0 feet below the crown (Permit No. 13907, 1985).					
Two 100-horsepower and one 75-horsepower pumps on pier at					
landward toe of levee. Siphon breaker on WS shoulder.					
FS Date: 8/27/2013

Pump on wooden pier at LS toe.

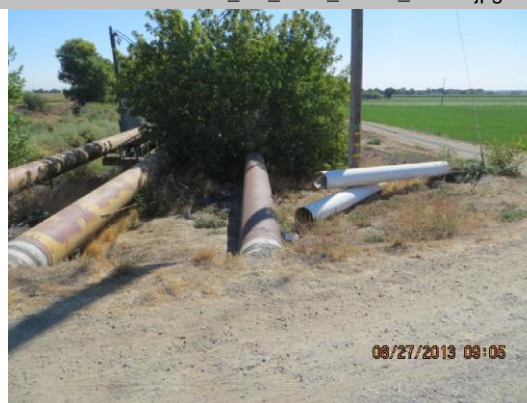
Photo 1 of 3 : UCIP_SP_2017_18720_31294.jpg

LM Start	0.06	Rating **	M	Issue No.	31
LM End	0.06	Issue Type +	En	Location *	LS
Category	Supplemental			GPS Latitude/Longitude	
				Start	End
Item	DWR UCIP Field Study			37.709672 °	37.709672 °
				-121.267532 °	-121.267532 °
DWR ID					
Comment Code					
Inspector Comment					
FS_ID:18720					
DS_ID:20528					
EP_NO: 13907					
Repair Type: Non-Urgent					
Crossing Status: Found					
UCIP Comments: This pipe has less than 1-foot of cover.					
FIELD_STRUCT_DESC: 3 of 3: 24-inch steel stormdrain discharge pipe					
through the levee 1.0-foot below the crown (Permit No. 13907, 1985).					
Two 100-horsepower and one 75-horsepower pumps on landward toe of					
levee. Siphon breaker on WS shoulder.					
FS Date: 8/27/2013

Steel pipe visible on LS.

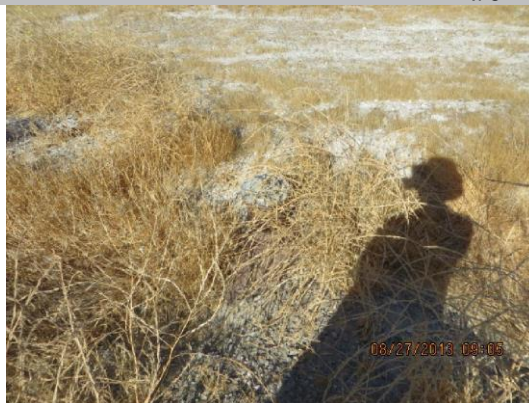
Photo 2 of 3 : UCIP_SP_2017_18720_31293.jpg

LM Start	0.06	Rating **	M	Issue No.	31 (cont)	
LM End	0.06	Issue Type +	En	Location *	LS	
Category	Supplemental			GPS Latitude/Longitude		
				Start	End	
Item	DWR UCIP Field Study			37.709672 °	37.709672 °	
				-121.267532 °	-121.267532 °	
DWR ID						
Comment Code						
Inspector Comment						
FS_ID:18720						
DS_ID:20528						
EP_NO: 13907						
Repair Type: Non-Urgent						
Crossing Status: Found						
UCIP Comments: This pipe has less than 1-foot of cover.						
FIELD_STRUCT_DESC: 3 of 3: 24-inch steel stormdrain discharge pipe						
through the levee 1.0-foot below the crown (Permit No. 13907, 1985).						
Two 100-horsepower and one 75-horsepower pumps on landward toe of						
levee. Siphon breaker on WS shoulder.						
FS Date: 8/27/2013

Siphon breaker visible on WS shoulder.

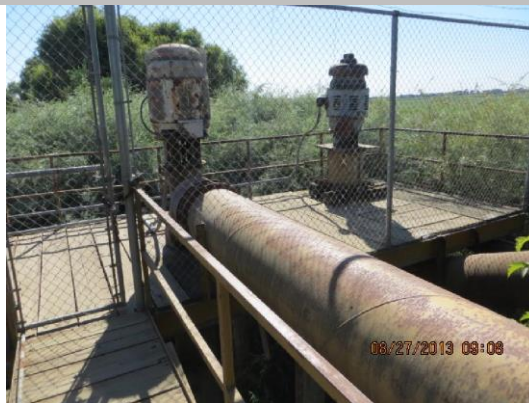
Photo 3 of 3 : UCIP_SP_2017_18720_31292.jpg

Pump on pier on LS.

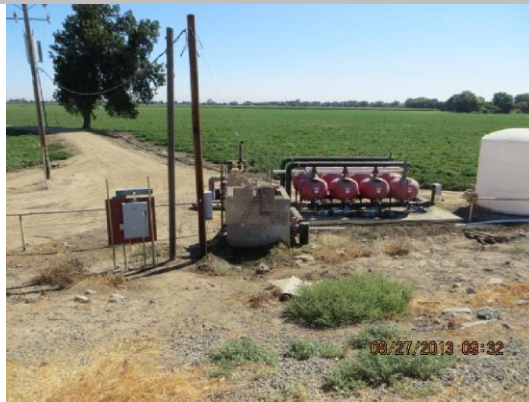
Photo 2 of 3 : UCIP_SP_2017_40792_31376.jpg

LM Start	1.23	Rating **	M	Issue No.	32
LM End	1.23	Issue Type +	En	Location *	WS
Category	Supplemental			GPS Latitude/Longitude	
				Start	End
Item	DWR UCIP Field Study			37.695529 °	37.695529 °
				-121.270005 °	-121.270005 °
DWR ID					
Comment Code					
Inspector Comment					
FS_ID:40792 DS_ID:20533 EP_NO: N/A Repair Type: Non-Urgent Crossing Status: Found UCIP Comments: Pump and slant pipe missing from structure on WS slope. FIELD_STRUCT_DESC: 12-inch steel concrete encased irrigation pipe through the levee 13.0 feet below the crown, slant pump on the WS toe. Slide gate in 36-inch CMP riser on the WS shoulder. 6'X6' concrete distribution box and filter plant on LS toe. 2-inch galvanized iron electrical conduit at same location. Originally included in the 1968 O&M manual. FS Date: 8/27/2013

Concrete distribution box and filter plant on LS toe.

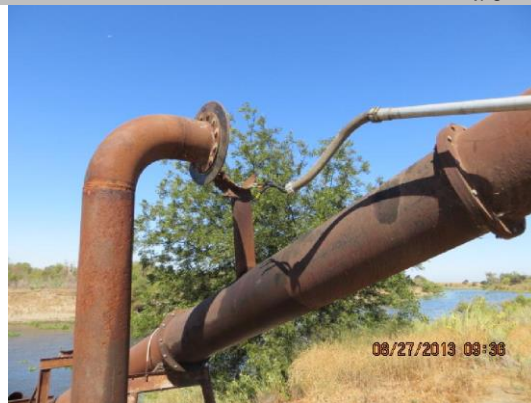
Photo 3 of 3 : UCIP_SP_2017_40792_31375.jpg

LM Start	1.23	Rating **	M	Issue No.	32 (cont)	
LM End	1.23	Issue Type +	En	Location *	WS	
Category	Supplemental			GPS Latitude/Longitude		
				Start		End
Item	DWR UCIP Field Study			37.695529 °		37.695529 °
				-121.270005 °		-121.270005 °
DWR ID						
Comment Code						
Inspector Comment						
FS_ID:40792						
DS_ID:20533						
EP_NO: N/A						
Repair Type: Non-Urgent						
Crossing Status: Found						
UCIP Comments: Pump and slant pipe missing from structure on WS slope.						
FIELD_STRUCT_DESC: 12-inch steel concrete encased irrigation pipe through the levee 13.0 feet below the crown, slant pump on the WS toe. Slide gate in 36-inch CMP riser on the WS shoulder. 6'X6' concrete distribution box and filter plant on LS toe. 2-inch galvanized iron electrical conduit at same location. Originally included in the 1968 O&M manual.						
FS Date: 8/27/2013

Pump and slant pipe missing from structure on WS slope.

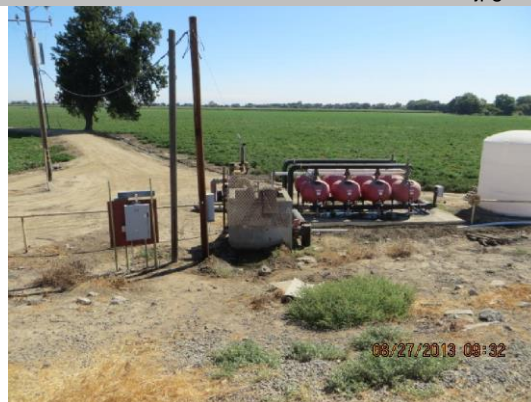
Photo 2 of 3 : UCIP_SP_2017_51638_38461.jpg

FS_ID:51638
DS_ID:20524
EP_NO: 3739
Repair Type: Urgent
Crossing Status: Found
UCIP Comments: 11/16/2016 same as last inspection leak has created sink hole near concrete distribution box located on the LS. Hole in pipe is visible at sink hole. Need to contact owner to address leak on LS. Recommend an internal inspection be completed for the pipe through the levee to determine pipe integrity. (O. Magana - DWR UCIP)08/27/2013 Some leakage at connection between pipe and distro box on LS toe. This may indicate internal failure of pipe. (W. Wylie - DWR UCIP)
FIELD_STRUCT_DESC: 16-inch steel irrigation pipe through the levee, 10.75 feet below the crown. 2-inch galvanized iron electrical conduit at same location. Slant pump is located on the waterside (WS) toe. Slide gate in 36-inch corrugated metal pipe (CMP) riser is located on the WS shoulder. 6-foot by 6-foot concrete distribution box and filter plant are located on landside (LS) toe. (16-inch pipe authorized under Permit No. 3739, 1961 - Mortensen & Barker)

Concrete distribution box on LS toe with filter plant.

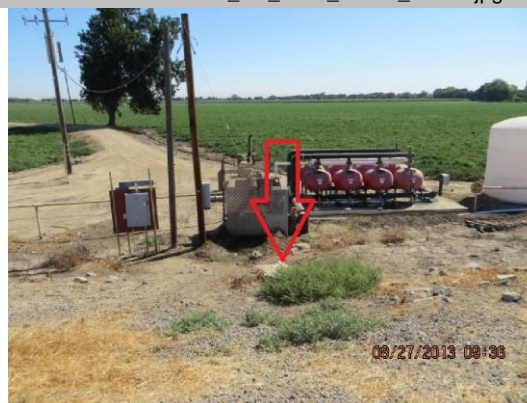
Photo 3 of 3 : UCIP_SP_2017_51638_38460.jpg

Comment Code					
Inspector Comment					
FS_ID:51638 DS_ID:20524 EP_NO: 3739 Repair Type: Urgent Crossing Status: Found UCIP Comments: 11/16/2016 same as last inspection leak has created sink hole near concrete distribution box located on the LS. Hole in pipe is visible at sink hole. Need to contact owner to address leak on LS. Recommend an internal inspection be completed for the pipe through the levee to determine pipe integrity. (O. Magana - DWR UCIP)08/27/2013 Some leakage at connection between pipe and distro box on LS toe. This may indicate internal failure of pipe. (W. Wylie - DWR UCIP) FIELD_STRUCT_DESC: 16-inch steel irrigation pipe through the levee, 10.75 feet below the crown. 2-inch galvanized iron electrical conduit at same location. Slant pump is located on the waterside (WS) toe. Slide gate in 36-inch corrugated metal pipe (CMP) riser is located on the WS shoulder. 6-foot by 6-foot concrete distribution box and filter plant are located on landside (LS) toe. (16-inch pipe authorized under Permit No. 3739, 1961 - Mortensen & Barker) FS Date: 11/16/2016

Leakage along pipe alignment on LS toe.

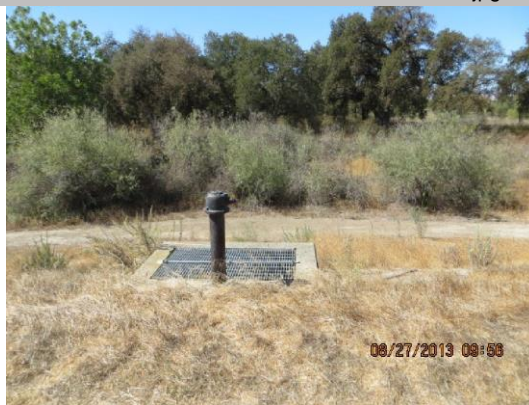
Photo 2 of 3 : UCIP_SP_2017_18748_31379.jpg

LM Start	1.65	Rating **	A/W	Issue No.	34
LM End	1.65	Issue Type +	Ma	Location *	WS
Category	Supplemental			GPS Latitude/Longitude	
				Start	End
Item	DWR UCIP LMA Responsibility			37.690072 °	37.690072 °
				-121.269823 °	-121.269823 °
DWR ID					
Comment Code					
Inspector Comment					
FS_ID:18748					
DS_ID:20514					
EP_NO: N/A					
Repair Type: No Action Needed					
Crossing Status: Found					
UCIP Comments:					
FIELD_STRUCT_DESC: 30-inch square reinforced concrete box culvert through the levee 15.0-feet below the crown. Slide gate in concrete riser unit on the waterward shoulder. Concrete "U" headwalls on both ends. Flap gate on the waterward end. Originally included in the 1968 O&M manual.					
FS Date: 8/27/2013

Slide gate in concrete vault on WS shoulder.

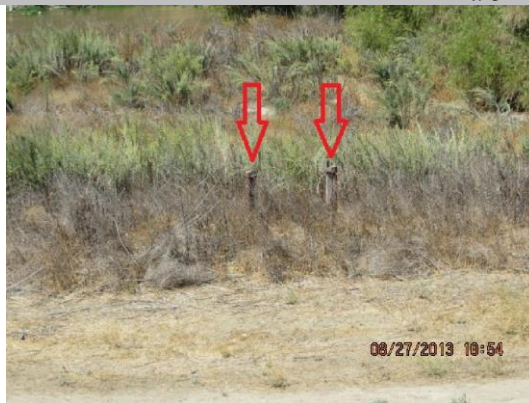
Photo 1 of 1 : UCIP_SP_2017_22731_38463.jpg

LM Start	3.46	Rating **	M	Issue No.	36
LM End	3.46	Issue Type +	En	Location *	WS
Category	Supplemental			GPS Latitude/Longitude	
				Start	End
Item	DWR UCIP Field Study			37.676751 °	37.676751 °
				-121.264193 °	-121.264193 °
DWR ID					
Comment Code					
Inspector Comment					
FS_ID:22731 DS_ID:20517 EP_NO: N/A Repair Type: Non-Urgent Crossing Status: Indicator Found UCIP Comments: Neet to verify status of pipeline. FIELD_STRUCT_DESC: Underground gas line crossing; depth through the levee and size unknown. Found possible sign posts on WS toe. FS Date: 8/27/2013

Possible sign posts on WS toe.

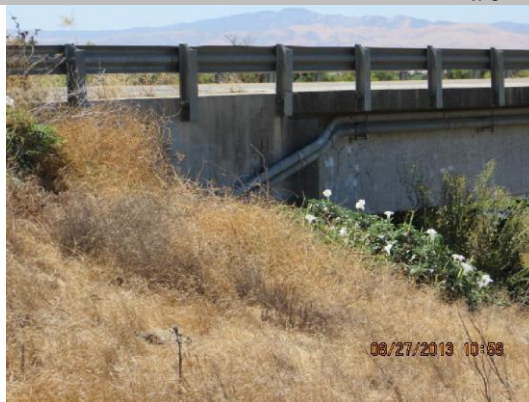
Photo 1 of 1 : UCIP_SP_2017_22085_37702.jpg

LM Start	3.49	Rating **	M	Issue No.	37
LM End	3.49	Issue Type +	En	Location *	WS
Category	Supplemental			GPS Latitude/Longitude	
				Start	End
Item	DWR UCIP Field Study			37.676276 °	37.676276 °
				-121.264104 °	-121.264104 °
DWR ID					
Comment Code					
Inspector Comment					
FS_ID:22085 DS_ID:24059 EP_NO: N/A Repair Type: Non-Urgent Crossing Status: Found UCIP Comments: Unable to identify purpose or permit for this crossing. FIELD_STRUCT_DESC: 1 of 2: 4-inch galvanized iron conduit through the levee at unknown depth below the crown. Visible on downstream side of the bridge. 3.5-foot by 6-foot steel vault on crown. FS Date: 8/27/2013

Upper conduit visible on DS side of bridge.

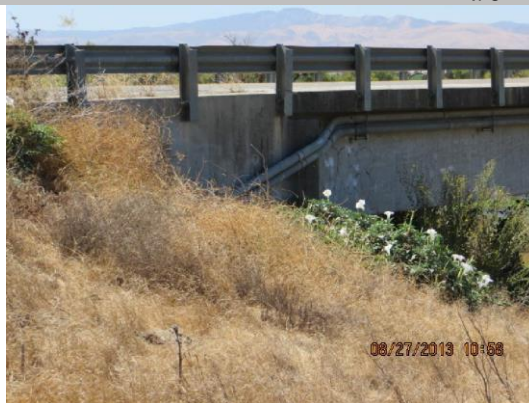
Photo 1 of 1 : UCIP_SP_2017_22790_38826.jpg

LM Start	3.49	Rating **	M	Issue No.	38
LM End	3.49	Issue Type +	En	Location *	WS
Category	Supplemental			GPS Latitude/Longitude	
				Start	End
Item	DWR UCIP Field Study			37.676276 °	37.676276 °
				-121.264104 °	-121.264104 °
DWR ID					
Comment Code					
Inspector Comment					
FS_ID:22790 DS_ID:24060 EP_NO: N/A Repair Type: Non-Urgent Crossing Status: Found UCIP Comments: Unable to identify purpose or permit for this crossing. FIELD_STRUCT_DESC: 2 of 2: 4-inch galvanized iron conduit through the levee at unknown depth below the crown. Visible on downstream side of the bridge. 3.5-foot by 6-foot steel vault on crown. FS Date: 8/27/2013

Lower conduit visible on DS side of bridge at WS slope.

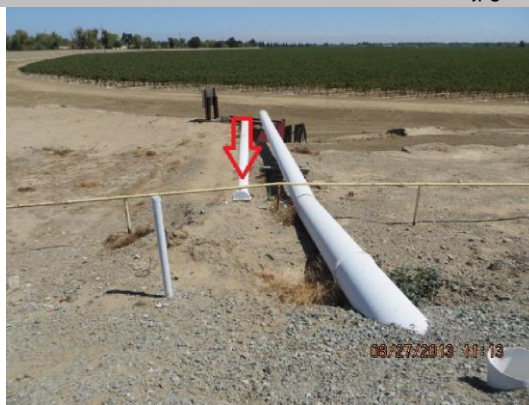
Photo 1 of 3 : UCIP_SP_2017_19044_31844.jpg

LM Start	3.57	Rating **	M	Issue No.	39
LM End	3.57	Issue Type +	En	Location *	WS
Category	Supplemental			GPS Latitude/Longitude	
				Start	End
Item	DWR UCIP Field Study			37.675267 °	37.675267 °
				-121.263426 °	-121.263426 °
DWR ID					
Comment Code					
Inspector Comment					
FS_ID:19044 DS_ID:20519 EP_NO: 6450 Repair Type: Non-Urgent Crossing Status: Found UCIP Comments: Appears abandoned and if so should be done so properly. FIELD_STRUCT_DESC: *ABANDONED* 18-inch steel discharge pipe through the levee 2-feet below the crown. Crown roadway padded over the pipe. Pipe exposed on both slopes. Gate valve on the LS toe. Pump missing from sump with sheet pile siding in ditch on the landside. Siphon breaker on the waterward side (Permit No. 6450, 1969). FS Date: 8/27/2013

Pipe and gate valve on LS toe.

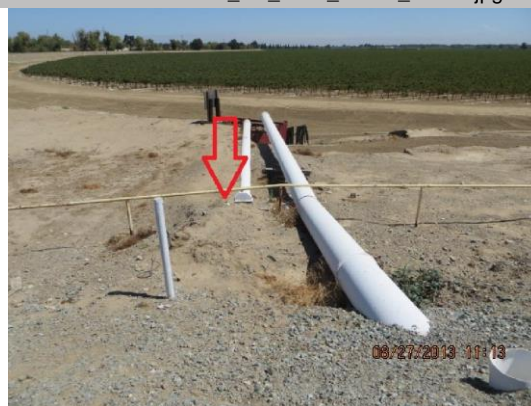
Photo 1 of 2 : UCIP_SP_2017_22732_38465.jpg

LM Start	3.57	Rating **	M	Issue No.	40
LM End	3.57	Issue Type +	Ma	Location *	WS
Category	Supplemental			GPS Latitude/Longitude	
				Start	End
Item	DWR UCIP LMA Responsibility			37.675266 °	37.675266 °
				-121.263421 °	-121.263421 °
DWR ID					
Comment Code					
Inspector Comment					
FS_ID:22732 DS_ID:20525 EP_NO: N/A Repair Type: Non-Urgent Crossing Status: Found UCIP Comments: Need to determine if pipe was actually removed from levee. FIELD_STRUCT_DESC: 12-inch steel stormdrain pipe through the levee at unknown depth below the crown. Steel plate welded over LS end at LS toe. Permit No. 6450, states it was removed in 1973, but it remains visible on the LS toe. Originally included in the 1968 O&M manual. FS Date: 8/27/2013

Pipe visible on LS toe.

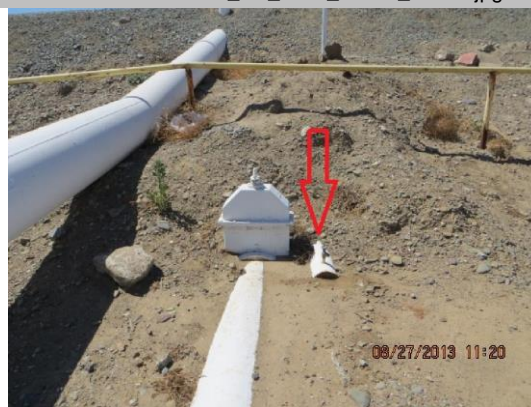
Photo 2 of 2 : UCIP_SP_2017_22732_38464.jpg

Pipe with welded steel plate over LS end at LS toe.

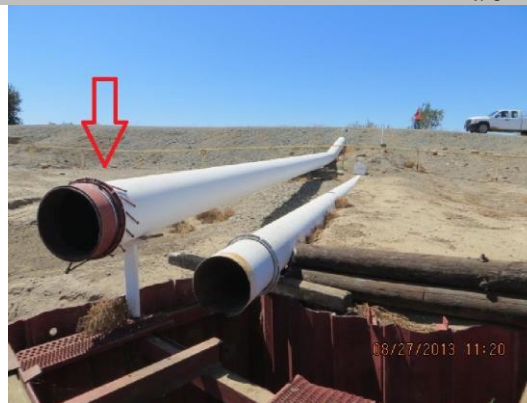
Photo 3 of 3 : UCIP_SP_2017_22733_38466.jpg

LM Start	3.57	Rating **	M	Issue No.	41 (cont)
LM End	3.57	Issue Type +	En	Location *	WS
Category	Supplemental			GPS Latitude/Longitude	
				Start	End
Item	DWR UCIP Field Study			37.675247 °	37.675247 °
				-121.263398 °	-121.263398 °
DWR ID					
Comment Code					
Inspector Comment					
FS_ID:22733					
DS_ID:20522					
EP_NO: 13609					
Repair Type: Non-Urgent					
Crossing Status: Found					
UCIP Comments: Appears abandoned and should be done so properly. Pipe was to be removed in 1984.					
FIELD_STRUCT_DESC: *ABANDONED* 1 of 2: 24-inch steel discharge pipe through the levee 2-feet below the crown (Permit No. 13609, 1983). Approx. 420 feet upstream of Durham Ferry-Airport Way Road.					
FS Date: 8/27/2013

Pipe open at pump sump off LS toe.

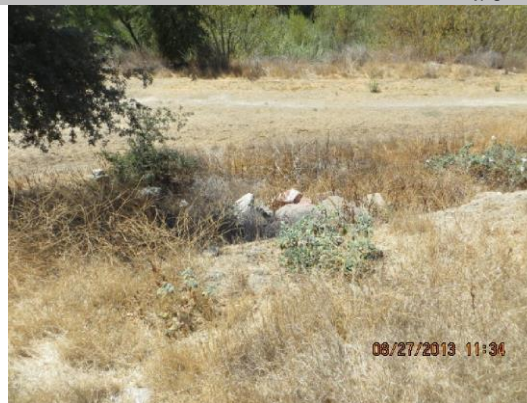
Photo 1 of 2 : UCIP_SP_2017_19046_31849.jpg

LM Start	3.60	Rating **	M	Issue No.	42
LM End	3.60	Issue Type +	En	Location *	WS
Category	Supplemental			GPS Latitude/Longitude	
				Start	End
Item	DWR UCIP Field Study			37.675005 °	37.675005 °
				-121.263103 °	-121.263103 °
DWR ID					
Comment Code					
Inspector Comment					
FS_ID:19046 DS_ID:20534 EP_NO: 13609 Repair Type: Non-Urgent Crossing Status: Indicator Found UCIP Comments: Pipes should be abandoned properly. FIELD_STRUCT_DESC: 2 of 2: *REMOVED* 24-inch steel pipe through levee 12.67 feet below crown (Permit No. 13609, 1983). Approx. 75 feet upstream of first 24-inch pipe. According to notes in permit, Concrete rubble was placed over pipe on WS slope. FS Date: 8/27/2013

Concrete rubble on WS slope possible indicator of abandoned pipe location.

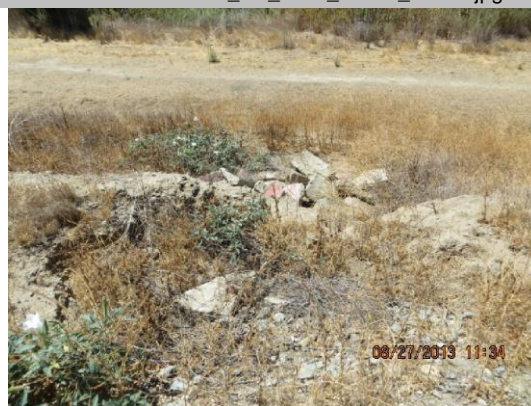
Photo 2 of 2 : UCIP_SP_2017_19046_31848.jpg

LM Start	3.60	Rating **	M	Issue No.	42 (cont)	
LM End	3.60	Issue Type +	En	Location *	WS	
Category	Supplemental			GPS Latitude/Longitude		
				Start	End	
Item	DWR UCIP Field Study			37.675005 °	37.675005 °	
				-121.263103 °	-121.263103 °	
DWR ID						
Comment Code						
Inspector Comment						
FS_ID:19046						
DS_ID:20534						
EP_NO: 13609						
Repair Type: Non-Urgent						
Crossing Status: Indicator Found						
UCIP Comments: Pipes should be abandoned properly.						
FIELD_STRUCT_DESC: 2 of 2: *REMOVED* 24-inch steel pipe						
through levee 12.67 feet below crown (Permit No. 13609, 1983).						
Approx. 75 feet upstream of first 24-inch pipe. According to notes in						
permit, Concrete rubble was placed over pipe on WS slope.						
FS Date: 8/27/2013

Concrete rubble on WS slope possible indicator of abandoned pipe location.

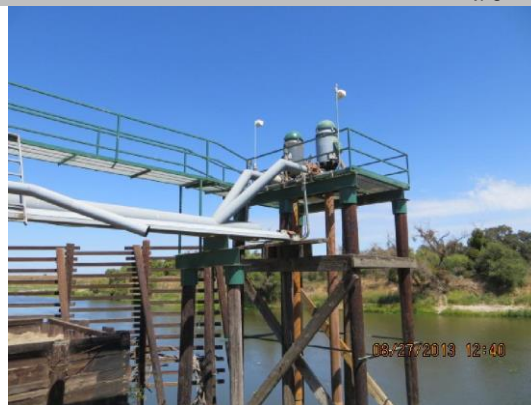
Photo 2 of 2 : UCIP_SP_2017_19063_31860.jpg

Pump platform, walkway, and fender remain in stream. No 24-inch pipe found.

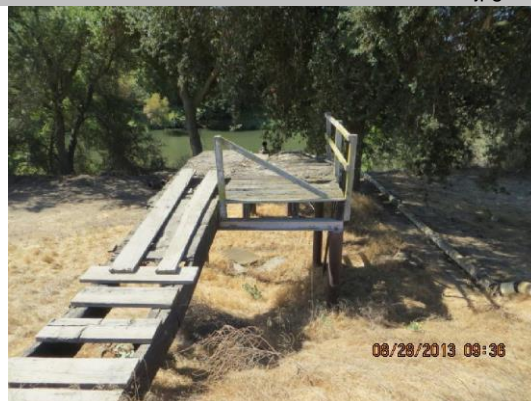
Photo 2 of 3 : UCIP_SP_2017_51385_31891.jpg

Deteriorated wooded pump platform on WS shoulder.

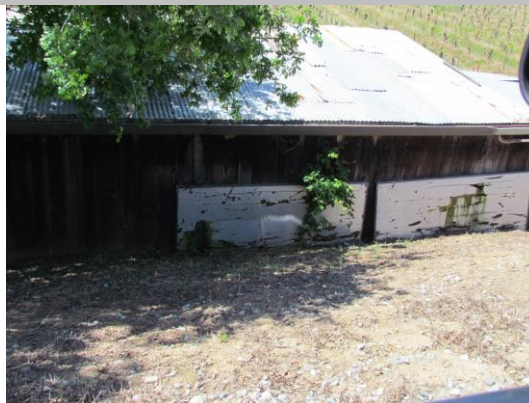
Photo 1 of 1 : SP_2017_RD2064_314_17_20170518_00047.jpg

RD 2064 looking upstream from levee mile 1.96 landside, building within the easement.

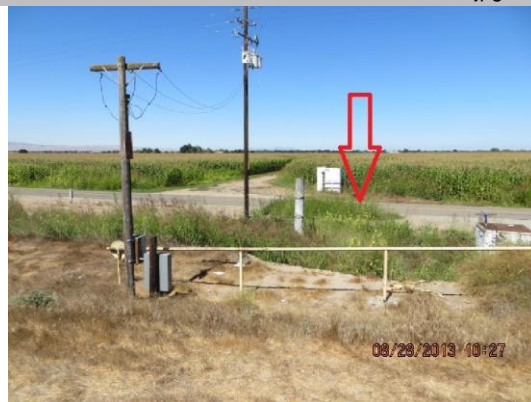
Photo 2 of 3 : UCIP_SP_2017_19086_31953.jpg

Wet area next to roadway off LS toe may indicate a leak. Power pole and meter on LS toe.

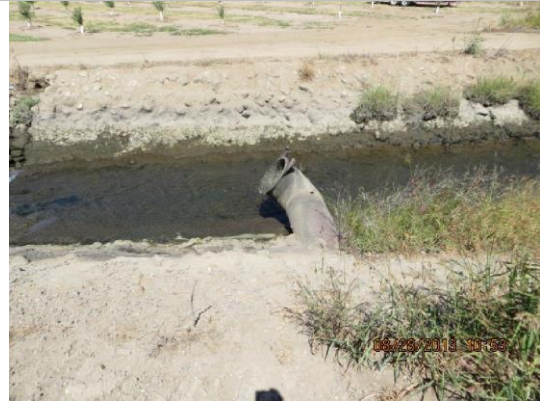
Photo 3 of 3 : UCIP_SP_2017_41075_31961.jpg

Pipe with missing flapgate on LS at concrete ditch.

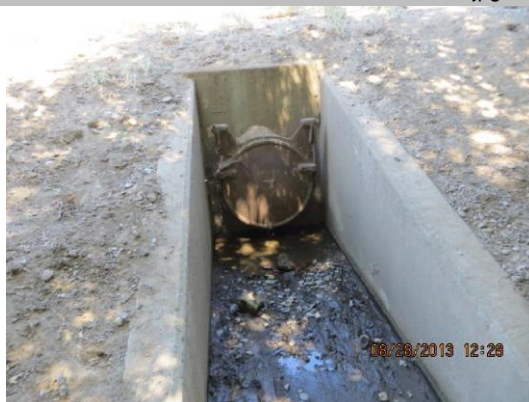
Photo 3 of 3 : UCIP_SP_2017_22108_37737.jpg

Evidence of discharge through PVC conduit on WS toe.

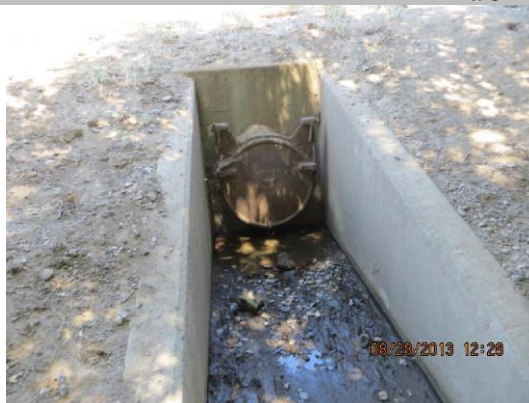
Photo 3 of 3 : UCIP_SP_2017_22109_37740.jpg

Evidence of discharge from PVC on WS toe.

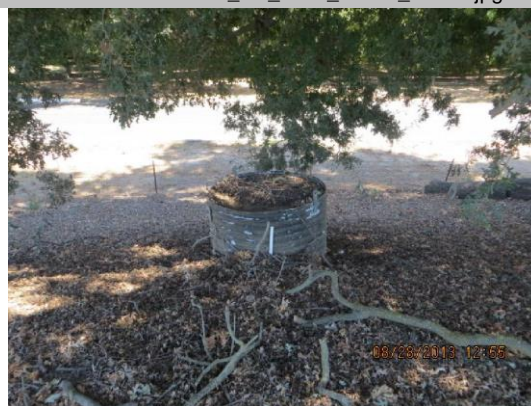
Photo 1 of 1 : UCIP_SP_2017_19146_32127.jpg

CMP riser for slide gate filled with soil.
